NEW APPROACHES TO WATER AND SEWER SERVICES
IN PERMAFROST AREAS
NORMAN WELLS, N.W.T.

W. W. Irwin
M. M. Dillon Limited
Edmonton, Alberta

1.3 Scope of this Paper

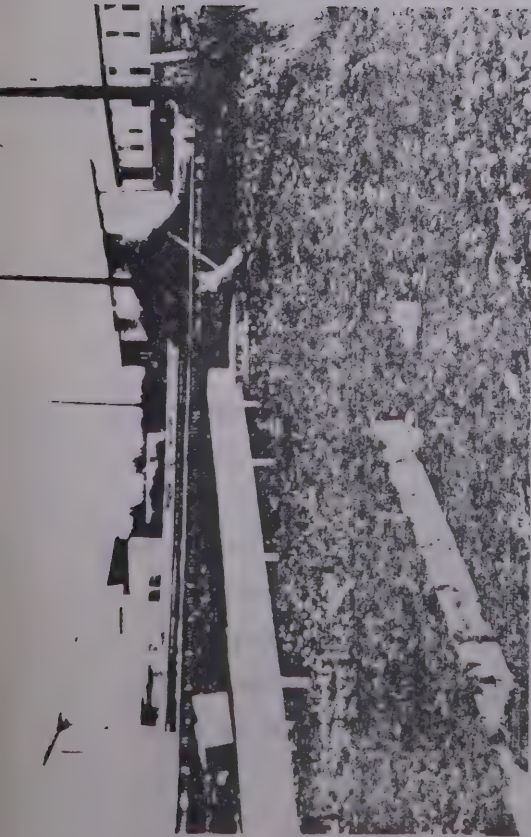
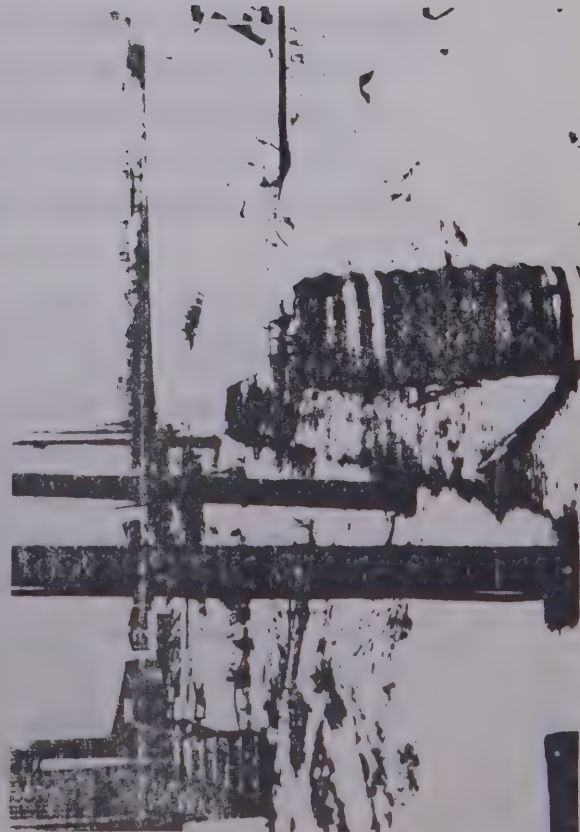
FIGURE 3

Federal System - Service Connections

N.W.T. System - Hydrant in Foreground

Federal System

TYPICAL UTILIDORS

CIRCA 1975

Typical views of the 1975 utilidors are shown in Figure 3.

- 4) Insulation in both systems was not performing well. Hygroscopic insulation (fibreglass and vermiculite), used in both systems, was being destroyed by wetting. Non-hygroscopic insulation (styrofoam) in enclosures carrying steam lines was melting.

- 5) Steam lines were corroding and failing due to moisture intrusion in the utilidor enclosures.
- 6) The wide variety of enclosures and piping systems in use was a nightmare for maintenance personnel trying to stock components for emergency repairs. In addition many of the enclosures were not designed for easy access to the piping inside. Removing a dozen 13 mm bolts in -45°C weather to gain access to a valve usually meant that the enclosure top was left lying loose until the following spring.

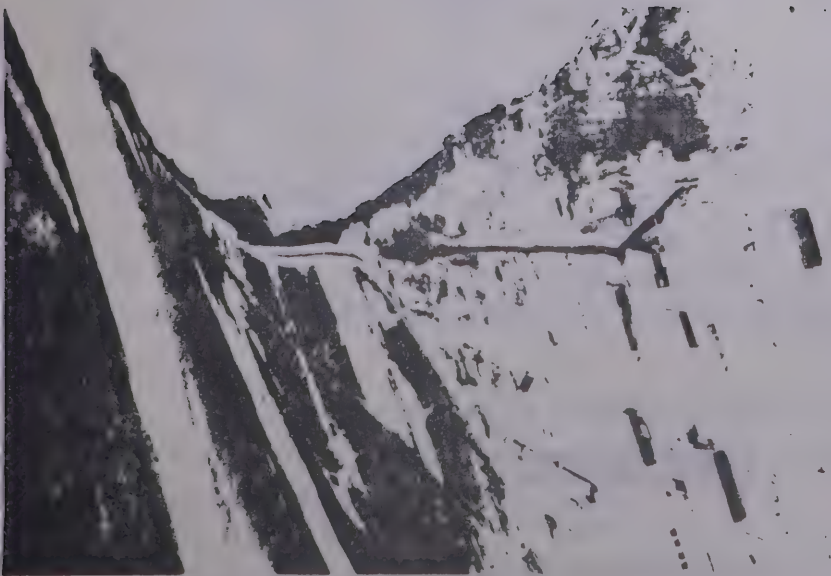
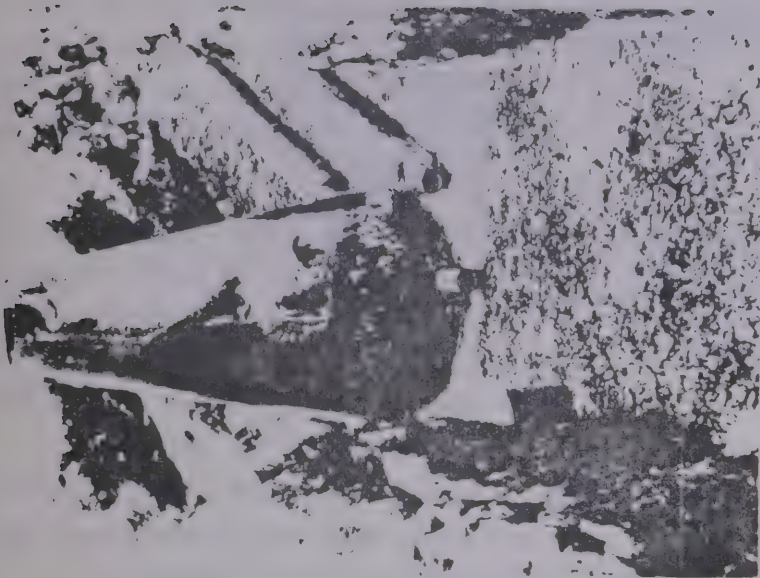
FIGURE 8

Excavation

Cleanout Chamber and Insulated Pipe

BURIED MAINS

non frost susceptible, less than 6 mm in nominal dimension and preferably non-angular. Materials permitted by specification were clean sands and screened shales, however, the successful contractor neglected to arrange for supplies of these materials early enough and coarse angular shale materials were used for much of the bedding. As a consequence further protection for jacketing material and insulation was required and a 5 mm asphalt-impregnated fibreglass protective sheeting was banded over the bundles exposed to this coarse bedding.

Backfill consisted of frozen native material with organics replaced on top, except under roadways where compacted shale was used.

As mentioned earlier some existing roadways had been build on an insulating layer of spruce slash. In trenches through these roads, styrofoam insulation was installed to replace the excavated slash.

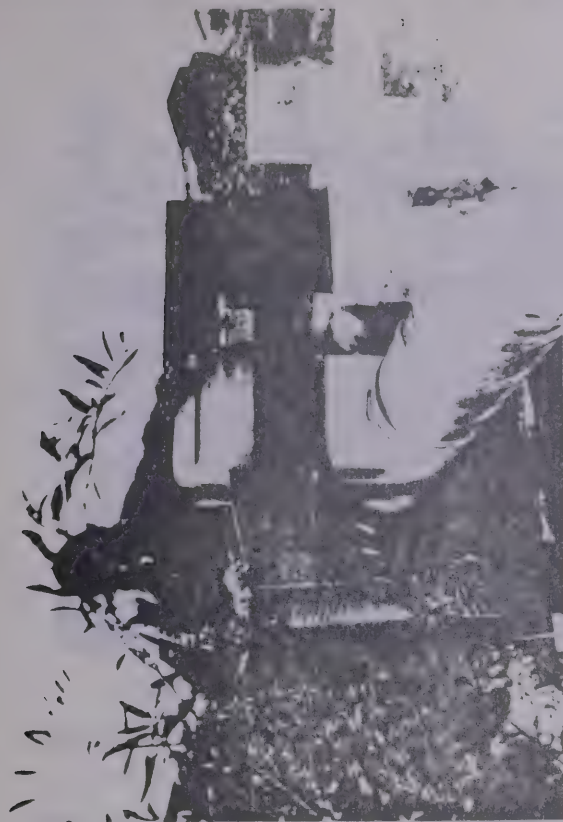
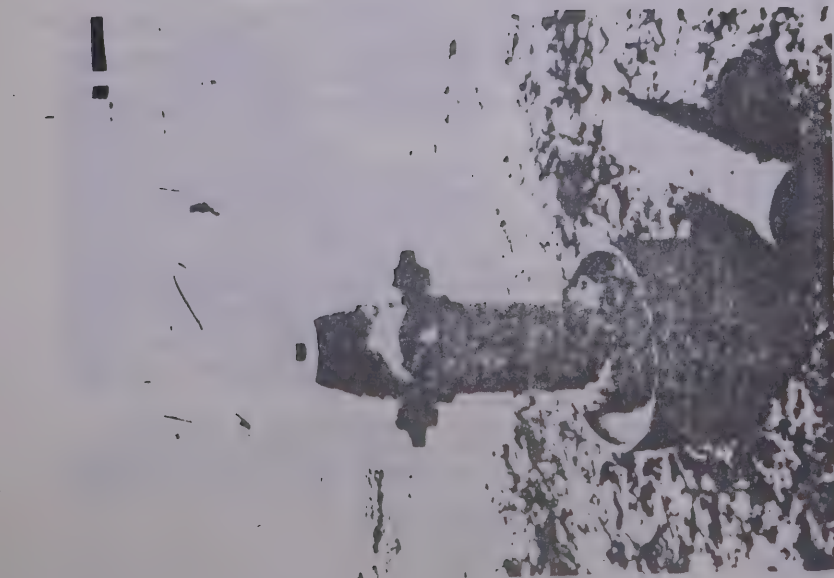
Above Ground

Buried

TYPICAL HYDRANTS
